Article

Response of the Downstream Braided Channel to Zhikong Reservoir on Lhasa River

Xinyu Wu ¹, Zhiwei Li ^{1,2}

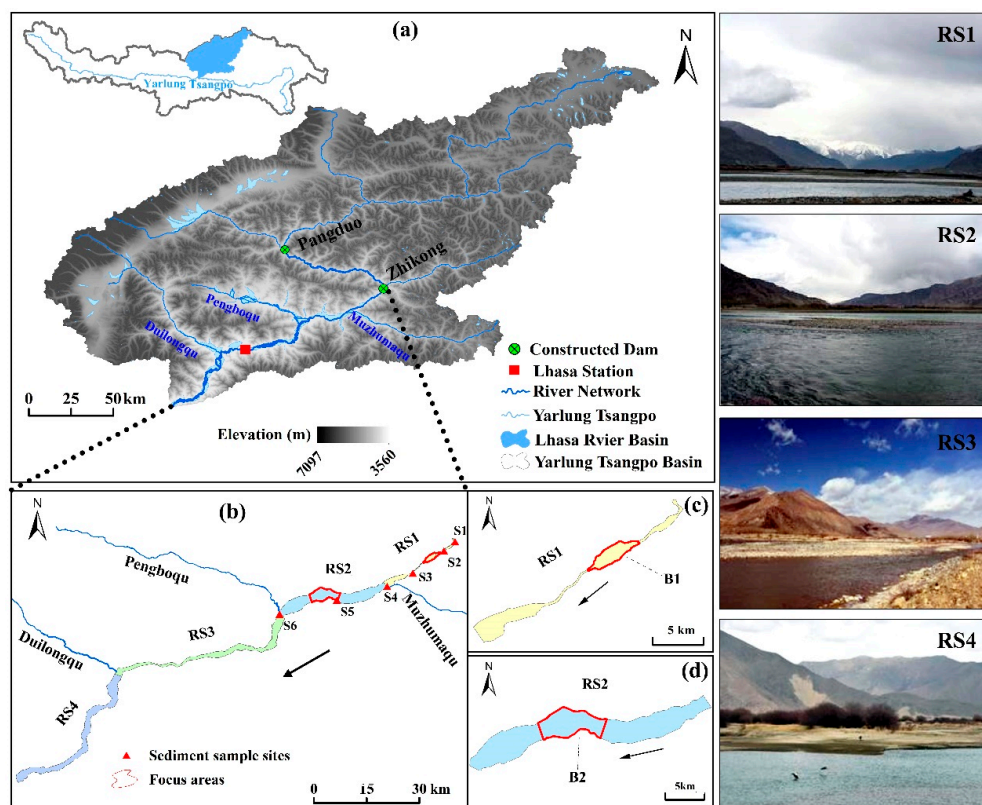
Figure 1. (a) Location of Lhasa River basin; (b) Four study reaches (whose extents were reflected by four different colors) divided by the confluences of three tributaries in lower Lhasa River and six sediment sampling sites (photos of four reaches took in March 2017); (c) A focus area B1 in RS1 (marked in red); (d) Another focus area B2 in RS2 (marked in red).

In the upper Lhasa River, Zhikong and Pangduo Dams were built in 2006 and 2013, respectively (Figure 1a). This study only focused on the downstream reach of the Zhikong Dam, which is 66.5 km below the Pangduo Dam, because the former has a larger contributing area than the latter does. The Zhikong Dam is located about 96-km upstream of the urban area of Lhasa City (Figure 1a). It has a contributing area of 20,179 km² with the mean annual discharge of 237 m³/s and annual runoff of 7.47 billion m³. Mean annual suspended load and bed load are 0.720 and 0.151 million tons, respectively [40]. The impoundment and operation of Zhikong Dam directly altered the hydrological regime of the downstream braided channel.

Lhasa hydrological station in the Lhasa City is 120 km below the Zhikong Dam (Figure 1a). Daily discharges from 1956 to 2010 measured at this station were obtained from the Hydrological Bureau of Tibet Autonomous Region. Satellite images of Landsat 8 OLI_TIRS, Landsat 7 ETM SLC-ON, Landsat 4–5 TM (United States Geological Survey, Reston, VA, USA) and Google Earth were selected for analyzing morphological changes. Unfortunately, these datasets were not successive and complete. For example, the suitable images (i.e., strip (138, 40)) in 2011 were not available. Instead, they were replaced by those on 11 April 2010. Although the spatial resolution of the Landsat images is only 30 m, it is sufficient to identify side and central bars in valley with the width of 1.5–3.0 km (Table 1). Images of satisfactory quality were finally selected to match the available daily or monthly discharges. Google Earth images with the resolution of 0.6 m were used to identify the accurate boundary of valley and local active channels of the studied reaches. These considerations ended up with Landsat strips (137, 39), (137, 40), (138, 39) and (138, 40) covering RS1, RS2, RS3 and RS4 in different combinations.

In addition, the local morphologic responses of two active segments (B1 in RS1 (Figure 1c) and B2 in RS2 (Figure 1d)) to the Zhikong Dam, were quantified using landscape pattern indices, which can quantitatively characterize wetland changes and spatial and temporal variations of landscape structure and fragmentation [42–45]. A single patch of braided channel in remote sensing images is defined as a bar separated by water flow. Patch number in RS1_B1 and RS2_B2 was calculated and patch density is defined as patch number per unit area. Three landscape pattern indices including mean dissection, landscape dissection and fragmentation shape were selected to quantify the inter- and intra-annual change of local braided channels (RS1_B1 and RS2_B2). The dissection index, D_i for bars is defined as the perimeter of a patch divided by that of a circle with an area equal to that of the patch. The mean dissection index (D) may be subsequently calculated using all D_i values, which is proportional to the landscape fragmentation [43,46]:

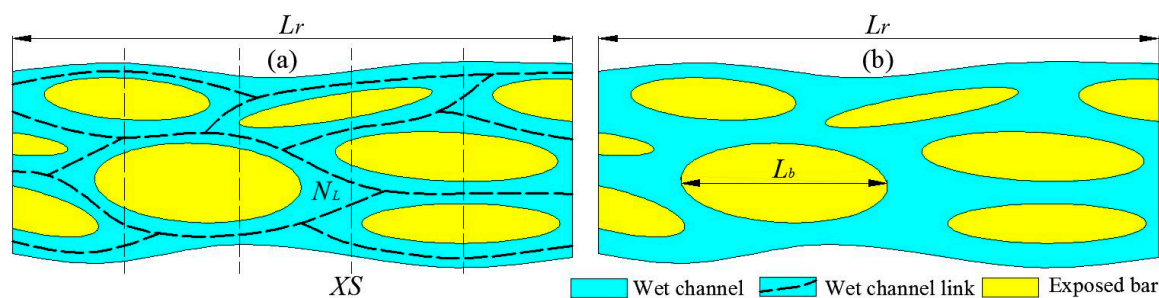
Figure 2. Diagrams of the parameters used for calculating braiding number and bar length indices (modified based on [41]).

Bar length index requires the measurement of the length of all gravel bars in each river reach (Figure 2b). We only selected RS1 and RS4 to calculate this index because these two reaches have the largest difference of the response to the dam, the former suffered the strongest impact from the dam, whereas the later was almost beyond the impact distance of the dam. In order to compare the morphological responses of different segments of RS1 and RS4 to the dam, we further divided RS1 and RS4 into three segments of equal lengths (DS1, DS2 and DS3).

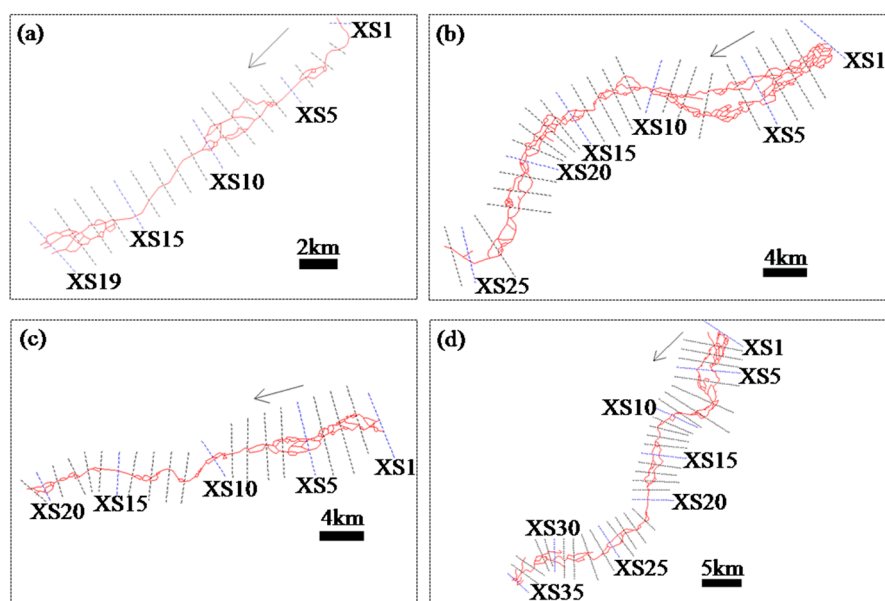
Figure 3. Simplified braided channels of the four reaches and the divided cross sections. The cross sections were named orderly from the first one in the upstream end (i.e., XS1) (a) RS1; (b) RS2; (c) RS3; (d) RS4.

The downstream reach of the Zhikong Dam is featured as a wide and complex braided channel. Its response to the impoundment of the dam was quantified by calculating the change of two braiding indices (braiding number index and bar length index) in 2001, 2011 and 2016 based on the method summarized by [41]. Extracting and calculating braiding number index (Figure 2a) do not need to consider the effect of channel width and bar size, so the channel reach in RS1, RS2, RS3 and RS4 was divided by cross sections with a 1-km interval and the centerline of braiding channel is simplified as a line (Figure 3). These sections along each line were denoted as a series of numbers after XS (e.g., XS1, XS5 and XS19 in Figure 3a).

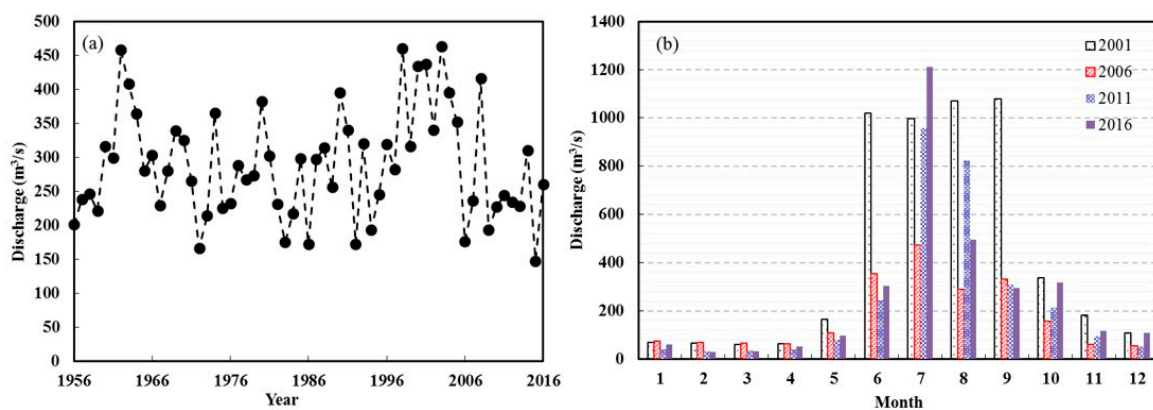
Mean annual discharge rate from 1956 to 2016 was 288.2 m³/s (Figure 4a). About 15.5% of it was attributed to the three above-mentioned tributaries based on the data from another station immediately below the dam (not shown here). The annual runoff had no obvious trend in the past 60 years even after 2006 when the Zhikong Dam was impounded [40]. The mean monthly discharge rate during the flood season (June–October) was 589.7 m³/s and the maximum discharge rate was 872.1 m³/s in August. During the dry season from November to May, the mean monthly discharge rate was 79.2 m³/s, only about 13.5% of that in the flood period. This large difference between the two seasons indicated that the change of braided channel morphology and riverine wetland dynamics mainly occurred in the flood period from June to October in the middle and lower Lhasa River.

Figure 4. (a) Mean annual discharge rates of Lhasa station from 1956 to 2016; (b) Mean monthly discharge rates of Lhasa station in the four representative years (i.e., 2001, 2006, 2011 and 2016).

The impoundment of Zhikong dam in 2006 changed the hydrological regime in the downstream Lhasa River. Monthly discharge in June, July, August and September in 1995–2005 decreased by 53.2%, 25.8%, 32.0% and 34.4% in comparison with that in the period of 2006–2016, respectively (Figure 4b). Moreover, the mean monthly discharge of the flood season in 1995–2005 was 844.7 m³/s, 34.4% higher than that in 2006–2010, which was 554.0 m³/s, indicating that the impoundment of Zhikong dam significantly decreased water discharges in the downstream channel during flood seasons.

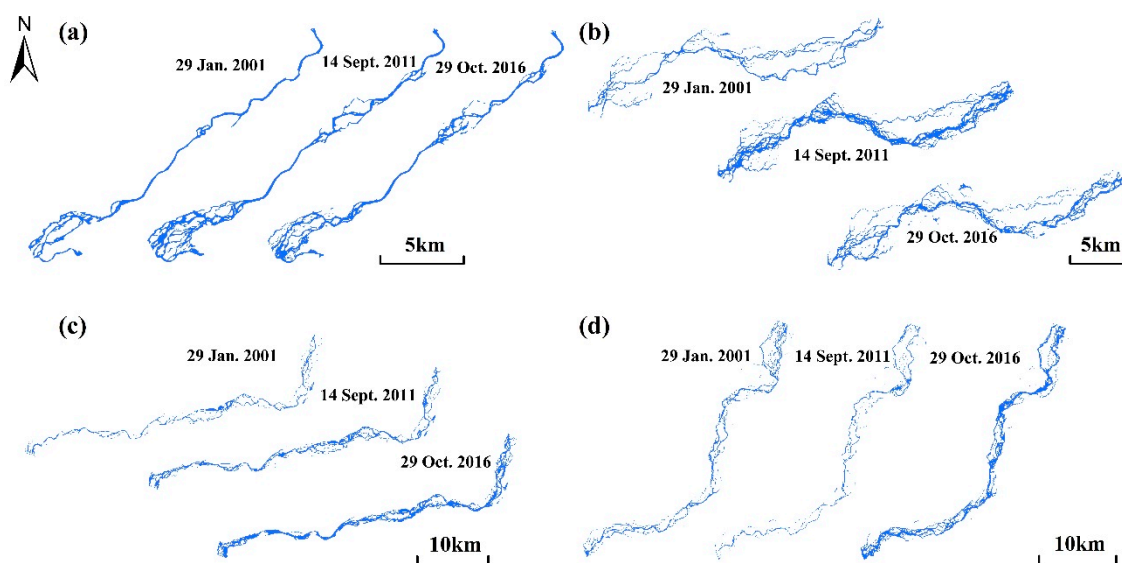
Figure 5. Morphological change of braided channel in four reaches along the channel in 2001, 2011 and 2016 (a) RS1; (b) RS2; (c) RS3; (d) RS4.

Covering periods of the pre- and post-construction of the Zhikong Dam, the images in 29 January 2001 (non-flooding period), 14 September 2011 (flooding period) and 29 October 2016 (non-flooding period) were used to analyze the different responses of the braided channel to the dam. In RS1, along the channel from the constrained single river reaches to the semi-constrained braided reaches, the number of channel branches apparently increased continuously from 2001 to 2016. Although such increase from 2011 to 2016 might be partially due to the lower water level in 2016 than that in 2011, it was obvious between 2011 and 2001 or 2016 and 2001, indicating the clear increase of central and side bars longitudinally after the dam construction (Figure 5a). About 5 km downstream of the dam, the originally single channel in 2001 became a braided channel with multiple branches in 2011. Similar change may be observed in the section toward the end of RS1 (Figure 5a).

In RS2, the number of braided branches increased greatly from 2001 to 2011, indicating a significant increase of the number of central and side bars after the dam construction. This increased number of braided branches from 2001 to 2011 within the same reach visually led to more fragmented bars in 2011 (Figure 5b). The apparent decrease of the number of braided branches in 2016 was mainly caused by the fact that water level was higher (in October) than that in 2011 (in September) (Figure 5b). In RS3, comparison of the size of the reach in three different periods showed that the extent of the downstream section of the reach tended to be reduced from 2001 to 2011 and remained unchanged afterward (Figure 5c). This change mainly reflected the impact of urbanization encroachment in Lhasa City. Our field observation three times in 2017–2018 showed that RS4 was an unconstrained braided river with many unstable bars or vegetated islands. Comparison of its size and shape among the three selected years indicated that there were no discernable temporal changes, suggesting the significantly reduced impact of the dam on its morphology due to the longer distance (Figure 5d).

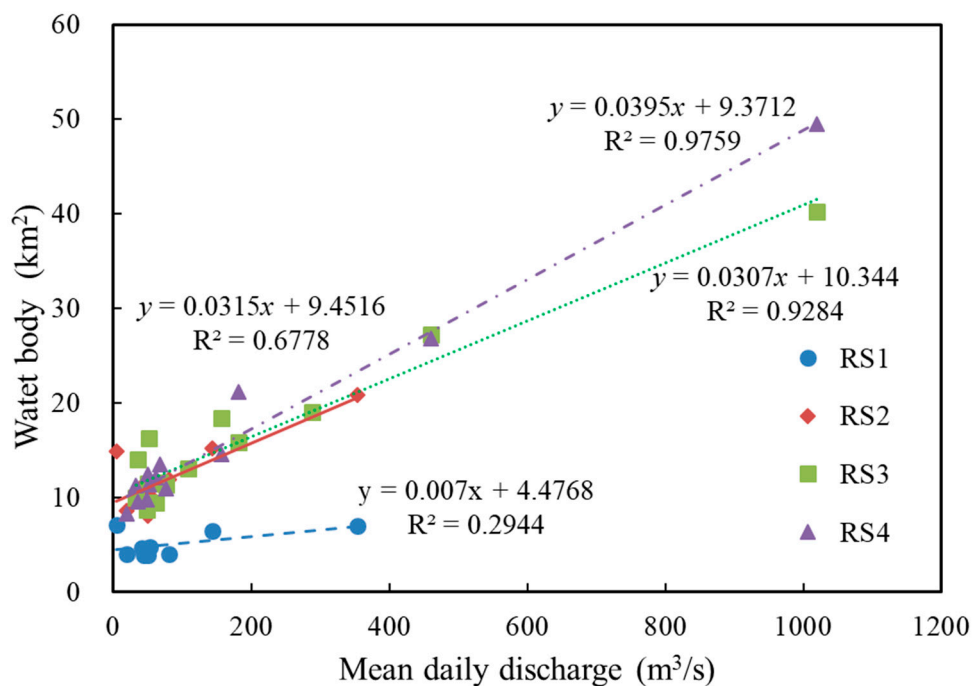
Areas of surface water in the 2001–2016 period were poorly correlated with the associated water discharges in RS1 with $R^2 = 0.294$ (Figure 6). For RS2, this correlation increased greatly with $R^2 = 0.678$. The two variables in RS3 and RS4 showed very strong correlations with R^2 greater than 0.92. The higher correlations in RS3 and RS4 indicated that as the discharge in these two reaches changed, the area of surface water of the braided channels changed following a similar trend (i.e., either increase with increased discharges or decrease with decreased discharges). This nature indirectly suggested that morphological structures of the braided channels in RS3 and RS4 had limited change during the

Figure 6. Relation between the mean daily discharge for each year from 2001 to 2016 at the Lhasa station and the area of surface water.

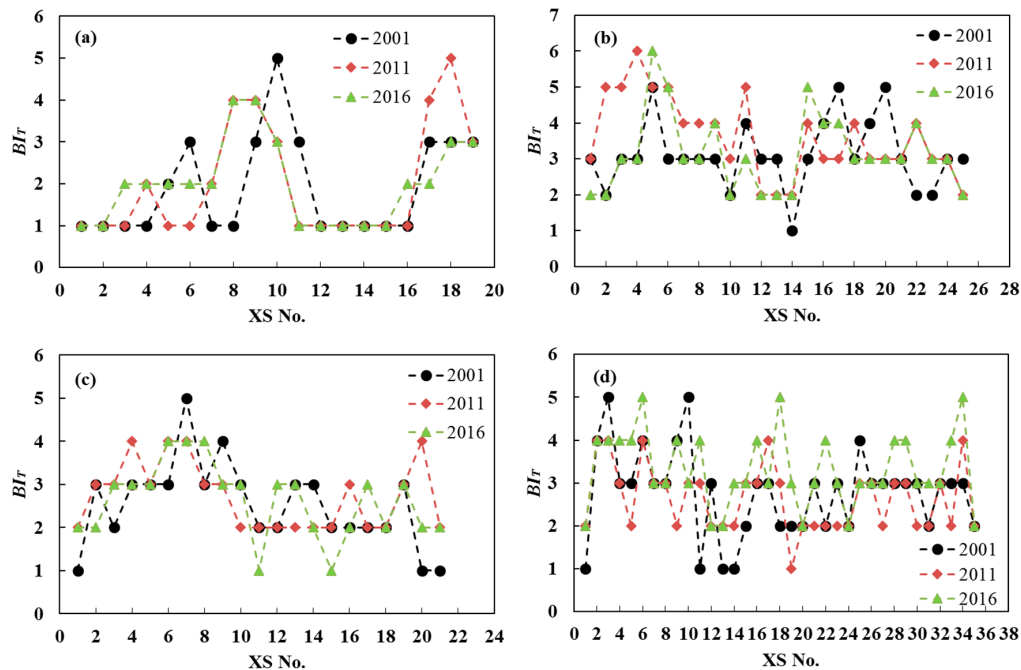
Figure 7. Changes of BI_T values in four reaches along the channel (a) RS1; (b) RS2; (c) RS3; (d) RS4.

Branches and central bars are the most sensitive morphological units that respond to the reservoir impoundment. Their changes were reflected by the temporal changes of braiding number index (BI_T) between the 2001–2011 and 2011–2016 periods (Figure 7). In RS1, values of BI_T remained unchanged for XS1-2 and XS12-15, which belong to single-thread constrained channel segments located in narrow valleys. Other cross sections with multithread channels in other sections changed from 2001 to 2011. Specifically, BI_T in XS3-4 increased by 1. Values of BI_T changed the most in XS8-11 with the largest increase in XS8 by 3 and decrease in XS10-11 by 2 (Figure 7a). From 2011 to 2016, most cross sections experienced no change or a change of BI_T by 1, while values of BI_T in XS17-18 were reduced by 2.

In RS2, BI_T of all multithread sections changed more or less in the 2001–2011 period (Figure 7b). In particular, BI_T in XS2 and XS4 increased by 3, in XS3, XS6 and XS22 increased by 2, in XS17 and XS20 reduced by 2. Most of changed sections were located in the upper part of RS2, which is closer to the dam. In RS3, other than that BI_T increased by 3 in XS20, all cross sections had minor changes in the 2001–2016 period (Figure 7c). In RS4, multithread channels in all cross sections changed randomly with no pronounced trend, which seemed to be consistent with the freely evolutionary nature of this braided

channel reach (Figure 7d). In summary, the change of BI_T slightly decreased from RS1 to RS3 with that in RS4 roughly kept unchanged. This quantitative pattern indicated that as moving downstream away from the Zhikong Dam, branches and central bars of braided channel reaches were affected by the construction of Zhikong Dam less and less.

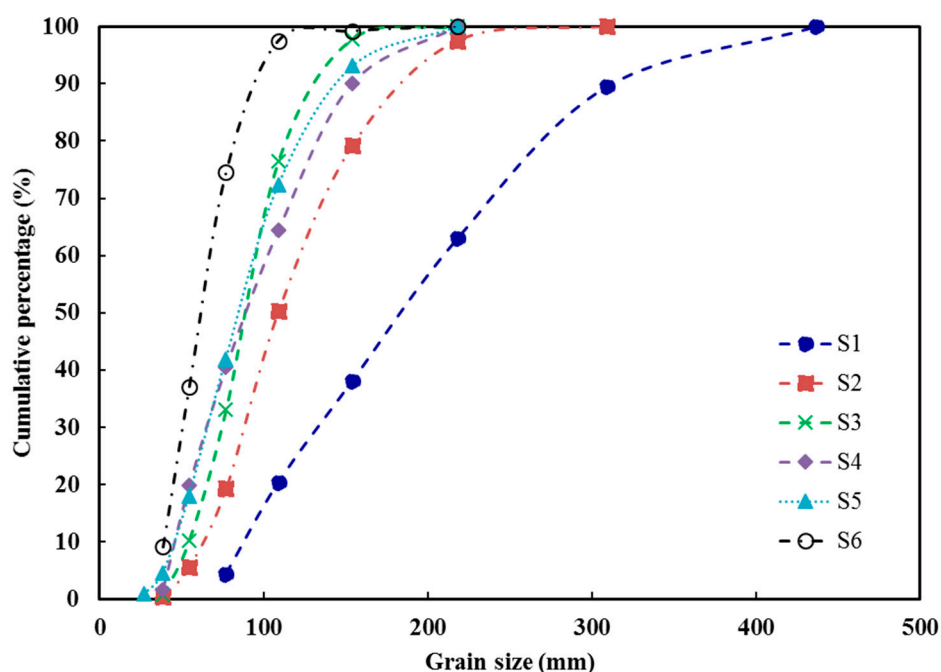
Particle size analysis showed that median size of gravels and boulders (D_{50}) decreases along the channel below the dam (i.e., 210, 130, 100, 100, 99 and 71 mm from S1 to S6) (Figure 8). Given that these six sites were located in RS1 and RS2 (Figure 1b), the decreasing trend of D_{50} indicated that the gravel bed materials in RS1 and RS2 were coarsened. In addition to the change of particle sizes, morphological changes of RS1_B1 and RS2_B2 (Figure 1c,d) during the 2001–2016 period (Figure 9) further revealed local responses of the braided channel to the Zhikong Dam.

Figure 8. Grain size distributions of surface bed materials at six sites in RS1 and RS2.

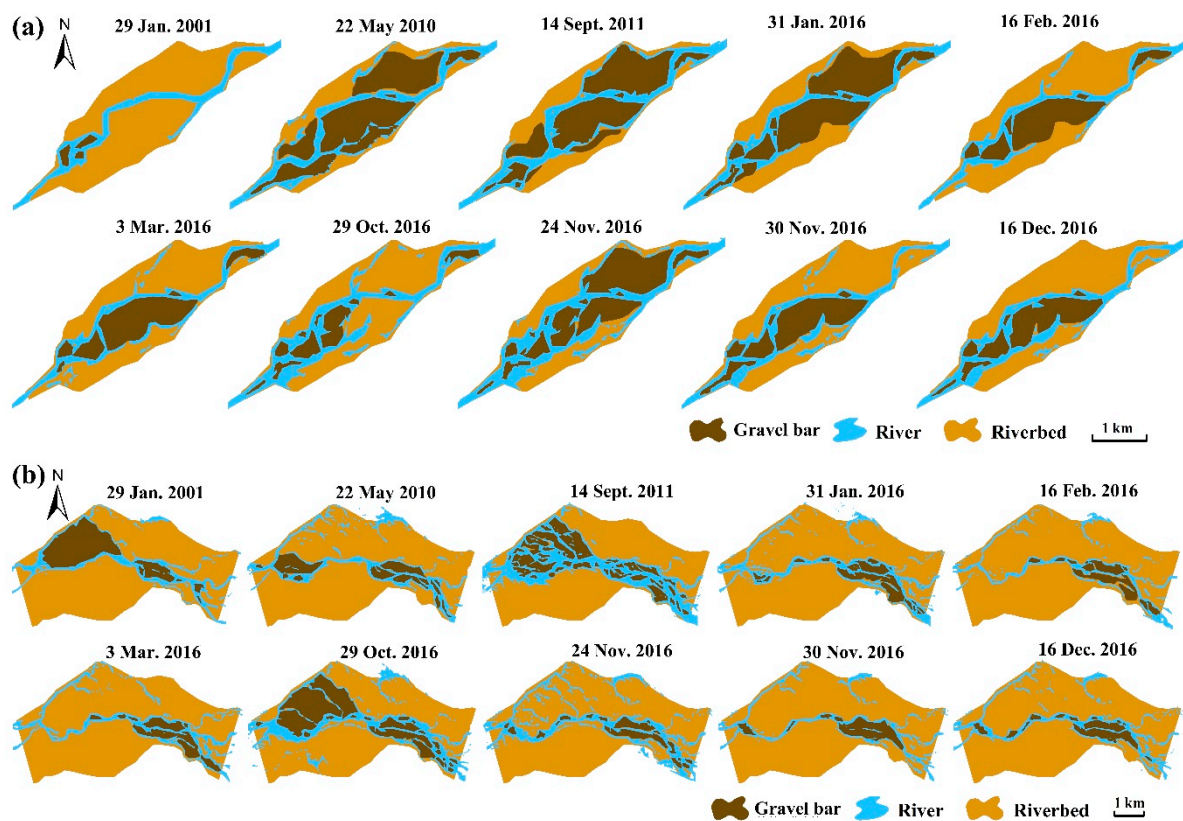
Figure 9. Morphological changes of local braided channel in RS1 and RS2 based on the remote sensing data. (a) RS1_B1; (b) RS2_B2.

The middle part of RS1_B1 was a wide and shallow braided channel and thus its morphological structure of bars and branches was relatively simple (Figure 9a). Yet, the channel morphology of RS2_B2 was more complicated than that of RS1_B1. Moreover, braided channels in RS2_B2 was out of phase with alternatively wide and narrow sections and the number of small patches (or bars) in RS2_B2 were generally 2–4 times greater than that in RS1_B1, while the patch density in RS2_B1 was 1.2–4.8 times higher than that in RS1_B2 (Table 3). Temporal changes of patch number and density in RS1_B1 may reflect variable discharges and the undulation of water levels. In winter, 2001, the patch density of central bars was 0.6, which was small. In dam operation, more bars in RS1-B1 were exposed

Another uncertainty tied to the response of braided channel to the dam construction is how to separate the effect of natural processes on the adjustment of the downstream braided channel from that of the dam. In other words, even if no reservoir was built upstream, the current downstream braided channel should have been continuously adjusted in flood and non-flood periods [22,54–57]. The greatest downstream impact of reservoirs is intercepting sediment load and reducing water level in flood seasons, which not only reduces sediment source of central and side bars but also weakens the intensity of riverbed adjustment. Therefore, though some degree of morphology adjustment may be due to regular hydrological changes, our results still clearly showed that operation of the Zhikong Dam lead to more bar exposition during flood seasons, prompting more vegetation encroachment and growth on bars and islands. The degree of such impact has decreased along the channel, such that this impact was barely identified in RS3 and RS4 (Figures 5 and 7). This highlights the importance of comparing the fragmentation indices of local segments (i.e., RS1_B1 and RS_B2) because they are closer to the dam and hence were more sensitive to the changed hydrological and sediment regimes due to the dam. This logic was confirmed by our results that the change of four indices in the two segments were different (Figures 9 and 10).

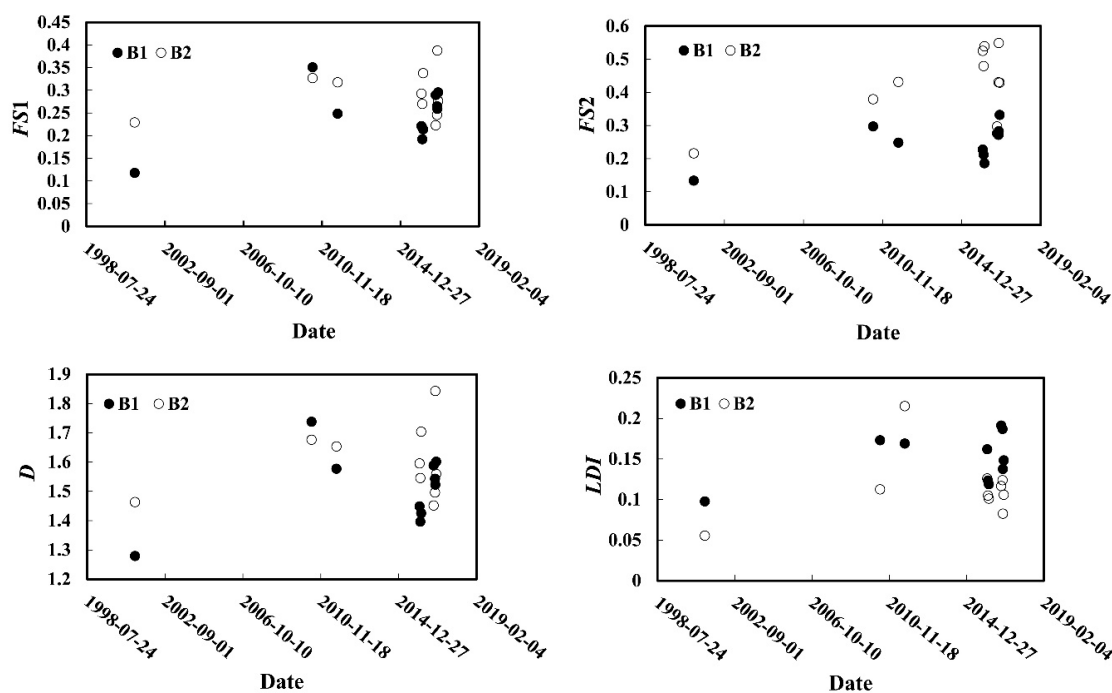
Calculated landscape pattern indices showed that the changing trend of the four indices of RS1_B1 and RS2_B2 had a similar increasing trend (Figure 10). Both the mean dissection index D and landscape dissection index LDI in RS1_B1 and RS1_B2 showed an increasing trend from 2001 to 2010–2016. In 2001, D and LDI were 1.28 and 0.098 in RS1_B1, while 1.46 and 0.056 in RS2_B2, respectively. In 2010–2016 they were 1.54 and 0.16 in RS1_B1 and 1.61 and 0.12 in RS2_B2, respectively. Temporal changes of D and LDI indicated that the degree of fragmentation of central bars in 2010–2016 was higher than that in 2001 (Figure 10). Meanwhile, the fragmentation shape index (i.e., $FS1$ and $FS2$) also showed an increasing trend, indicating that central bars changed greatly in an irregular shape likely indicating the clean water release of Zhikong Dam eroded the downstream riverbed of braided channel. The similar temporal trends of these four indices not only mutually verified the above-mentioned nature of the changes of fragmentation but also quantitatively revealed the downstream effect of the dam on the local channel segments.

Figure 10. Changes of four landscape pattern indices in RS1_B1 and RS2_B2 during 2001–2016.

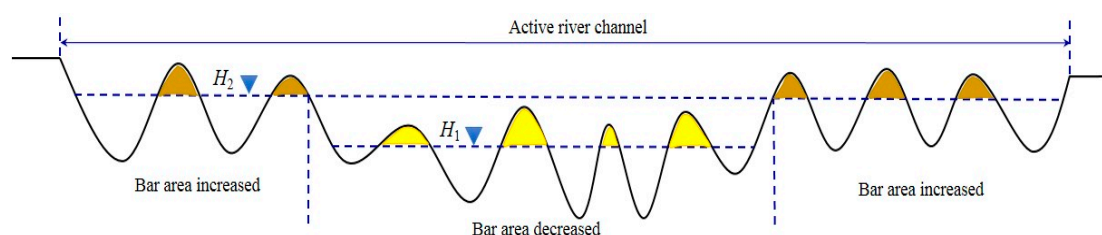
Figure 11. Schematic diagram of impacts of water level rising on braided channel within active river channel of the middle and lower Lhasa River.

The final uncertainty concerned the fact that the number of bars and branches was not a monotonic function of water level. Discharge increase may lead to decrease of the bar number in the main active channel but increase of the bar number in partially active channels close to both banks (Figure 11). Specifically, the complexity of water level changes caused by the operation and management of the Zhikong Dam was the consequence of two opposite effects in braided reaches: (1) reducing the released discharge in flood season and (2) increasing the released discharge in non-flooding season (Figure 11). The former may either reduce the bar number by scouring or increase the bar number by lowering water level in the entire active river channel. Similarly, the latter may reduce the bar number by increasing water level, which may submerge more bars in the active main channel or increase the bar number by raising water level in the entire active channels, which expand the lateral extent of the active channels. This complex dynamic needs to be studied further with more process-based data on riverbed topography.

At low water levels, numbers and areas of (side and central) bars and islands might be increased, whereas at high water levels, the opposite case occurs (Figure 11). This pattern indicates that more physical habitats are possibly available during relatively low flows. Nonetheless, the increased physical habitats are insufficient to guarantee the development of new riverine wetlands as vegetation growth on these bars require nutrients that are typically attached to fine sediments. The arrival of these fine sediments from the reservoir to these bars and islands relies on relatively high flows that may carry enough fine sediments to the downstream reach. In addition, fine sediments with rich nutrients may be also carried downstream partly by natural high flows from the three tributaries to the study reach (Figure 1b). Consequently, it is important to understand the coupling effect between the dam-altered hydrological regime in the main channel of the study reach and the natural flow regimes in the three tributaries within the studied reach. This would provide valuable scientific guidelines on the optimum reservoir operation that can achieve its multiple roles including flood control, agricultural irrigation and reestablishment of new braided riverine wetlands.
